Biomark Product Technical Bulletin

Destron Fearing FS2001-F and FS2001-ISO

8-June-2018 (Rev A)

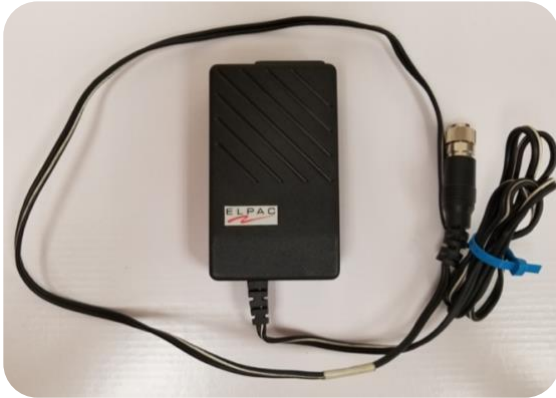
A FS2001 reader will operate without its battery when used with:

FS2001 Elpac Power Supply
(Model: M42012)

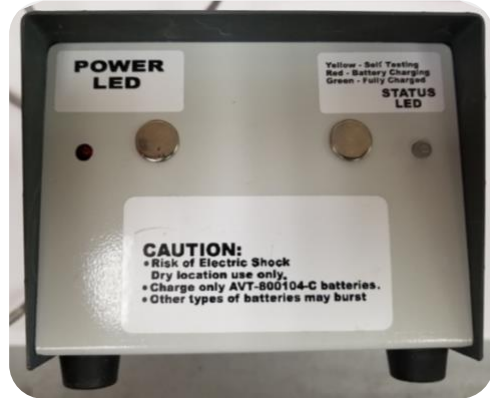
FS2001 AVT Power Supply/Battery Charger Combo
(Model: AVC-H80024A)

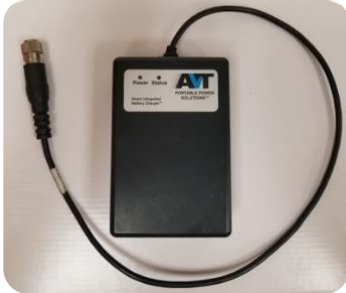
Note: A FS2001 will NOT operate and read tags without its battery plugged in when used with a AVT Battery Charger (Model: C3H4-10-400-YA):

For charging FS2001 ONLY. This is NOT a power supply.
