BIOMARK PROJECTS

SEDIMENT MOVEMENT

Researchers are using a custom designed Biomark antenna system to track sediment movement in San Juan River. The data is being used to study geomorphic change, sediment dynamics and impacts to fish habitat.

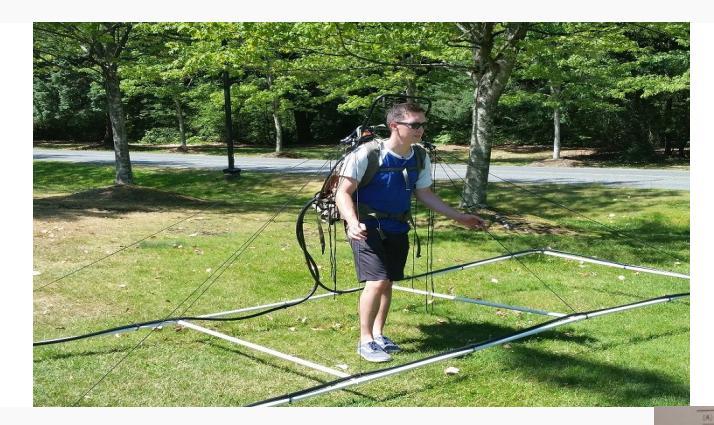
Photo 3: The Mark III in action.

The current antenna assembly consists of an IS1001 board with BLE logger attached to a cable antenna. The system is controlled using a Microsoft Surface via Bluetooth. The cable antenna is attached to a 15' x 5' frame constructed from 3/4" schedule 40 PVC suspended from a frame pack on adjustable ropes. HPR Plus readers with BP Plus antennas are used for localized searching.

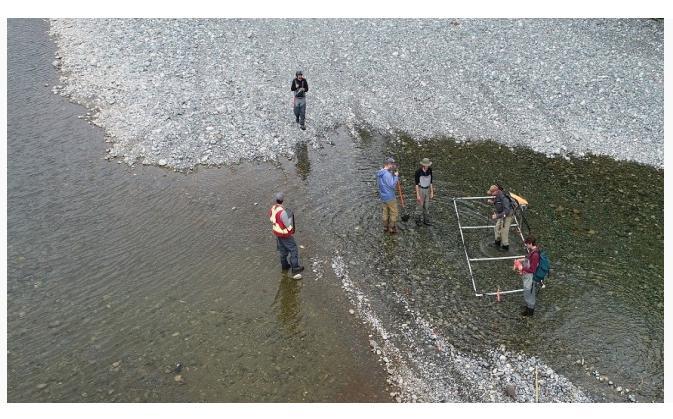
Photo 4: The Mark III.

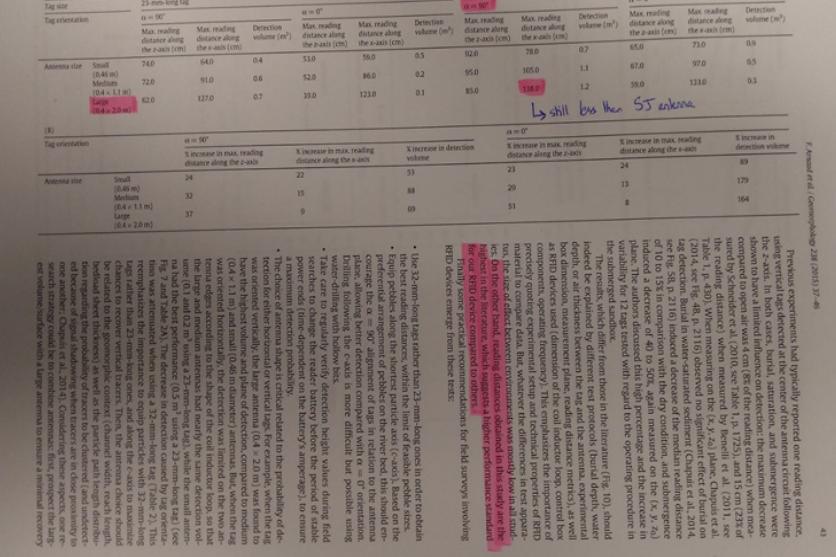
Photo 5: The Read range paper.

Our Biomark antenna has a better read range than the best we could find reported in the literature. The results of our rock search in the San Juan River have achieved an average tag recovery rate of about 75%. This significantly exceeds any other reported in the literature for rivers of similar size. The closest comparable rivers reported recovery rates of about 45%. We have gone so far as to proclaim an unofficial world record in recovery rate for tracers on large rivers.
